CALIFORNIA DIVISION OF MINES AND GEOLOGY

FAULT EVALUATION REPORT FER-130

Goose Lake and related faults, Humboldt County.*

Hydesville 7.5-minute quadrangle.

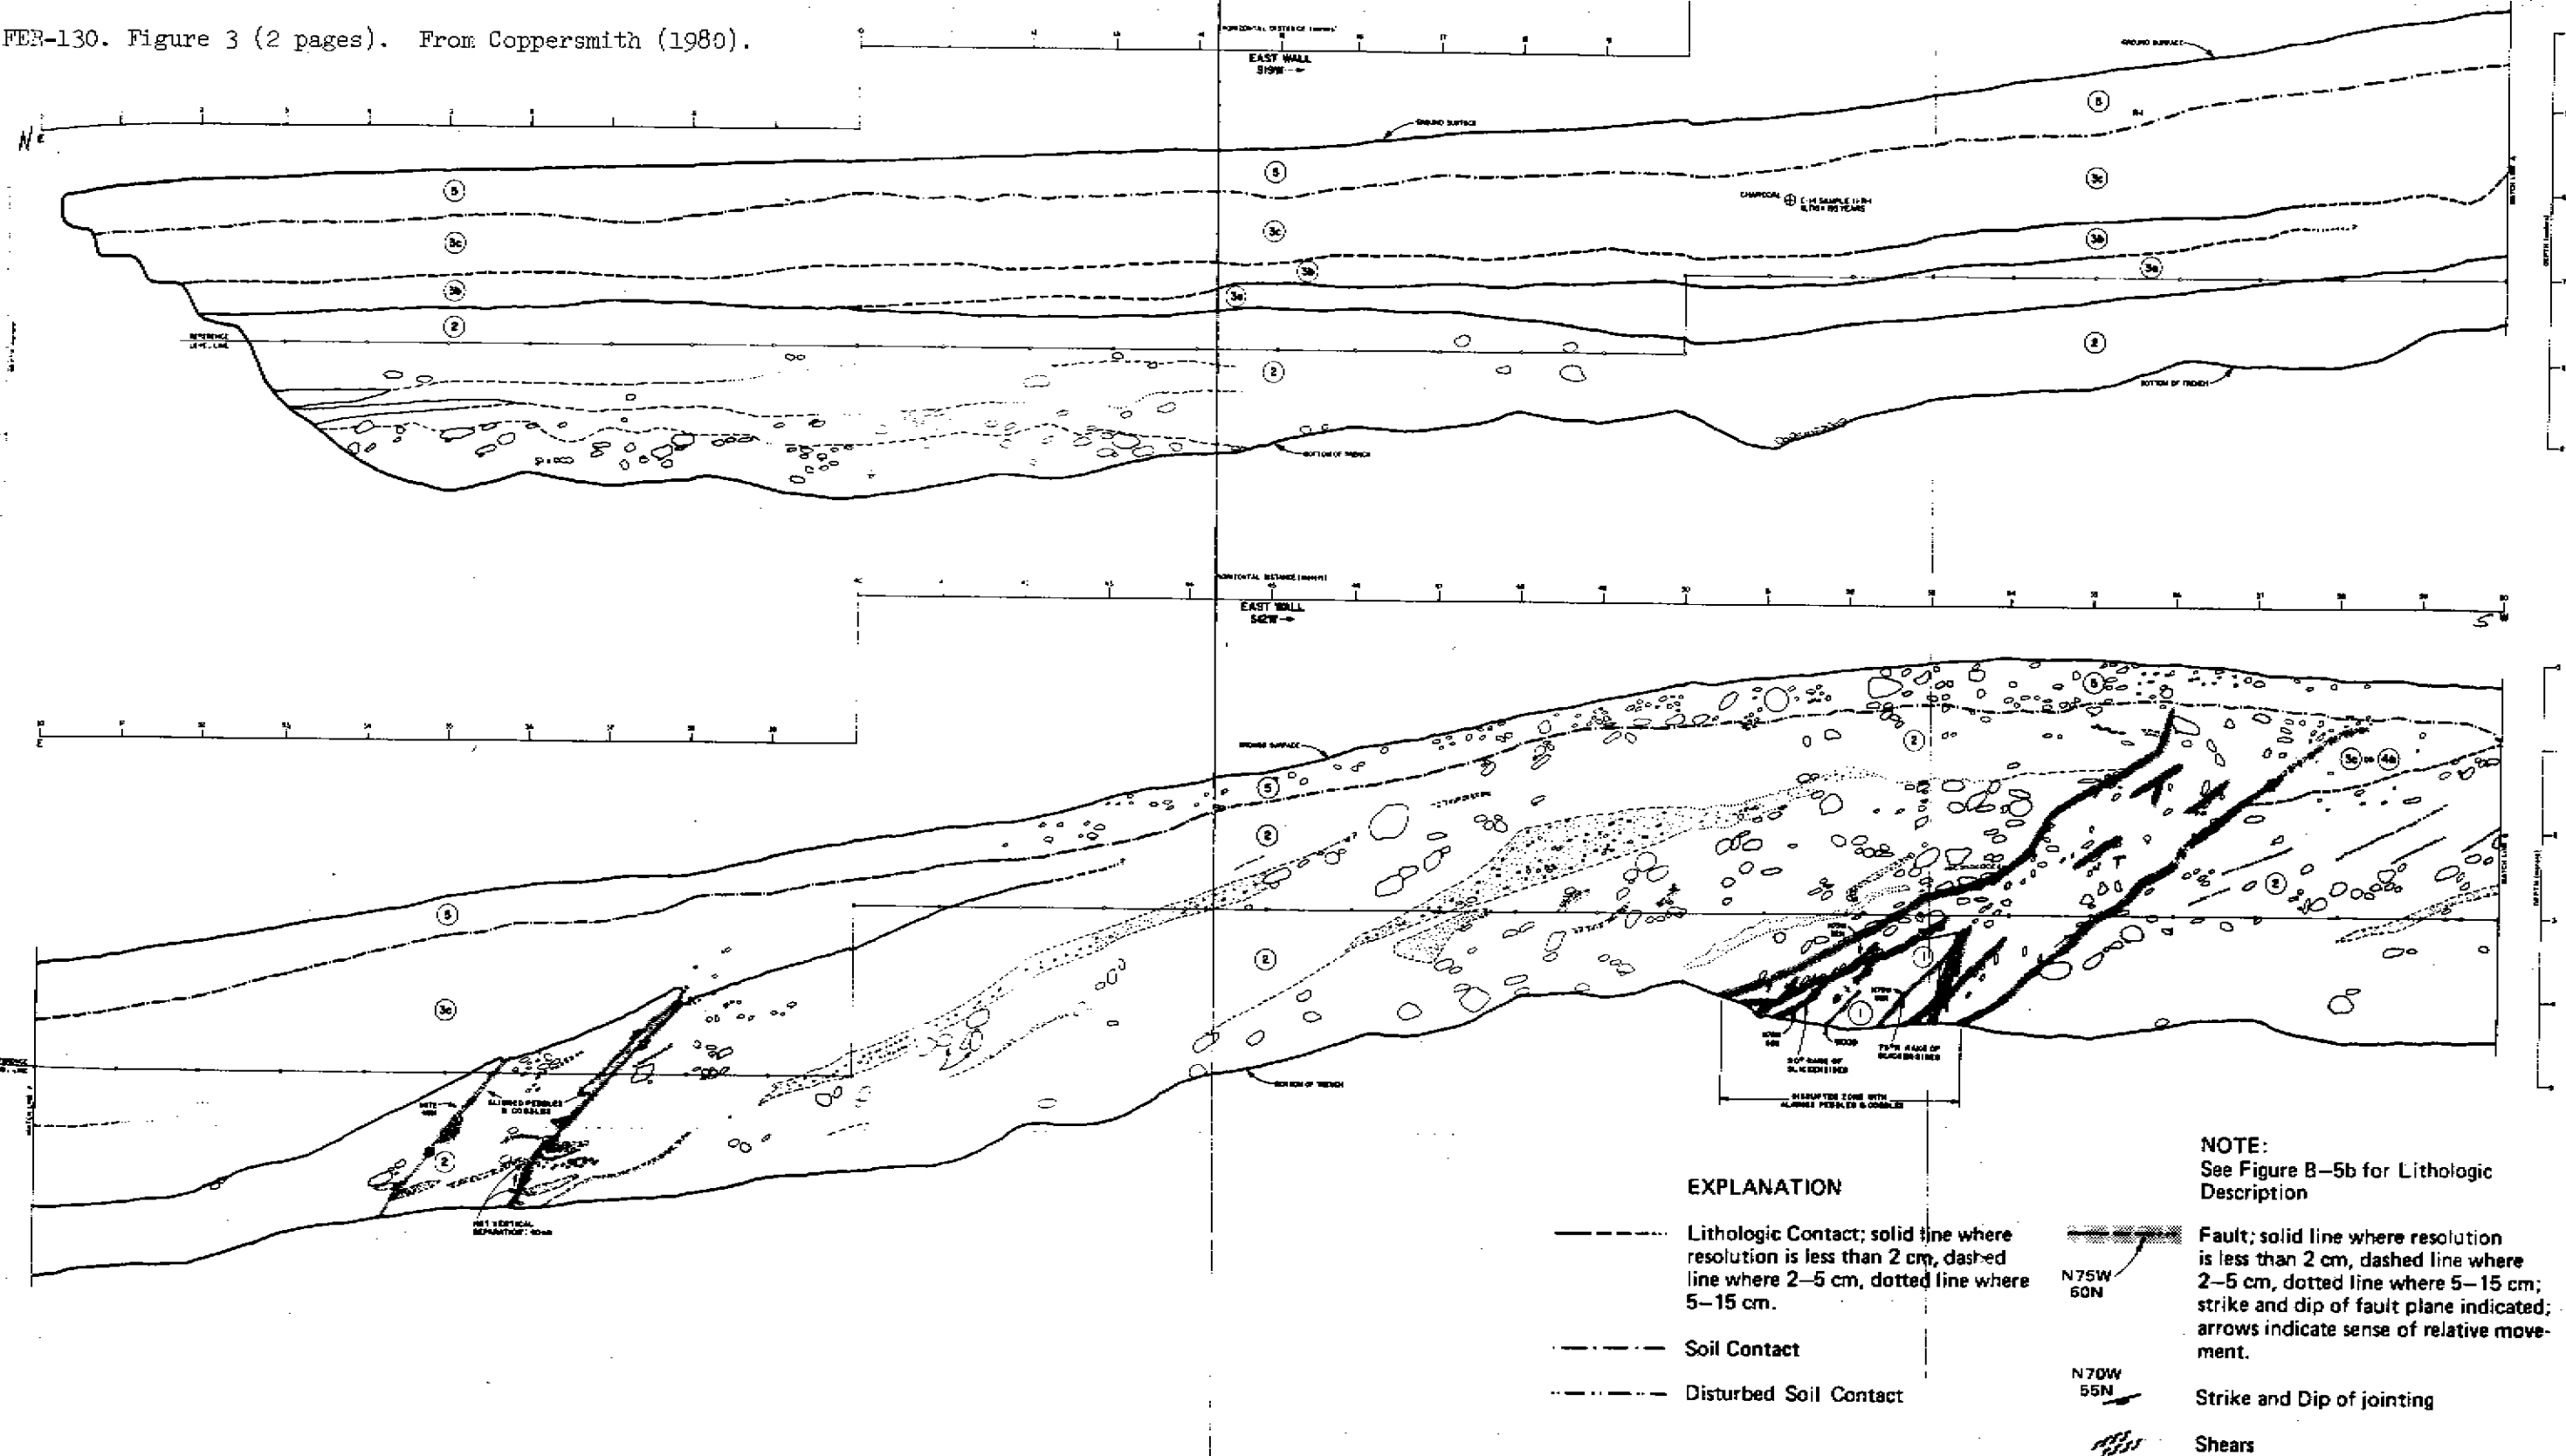
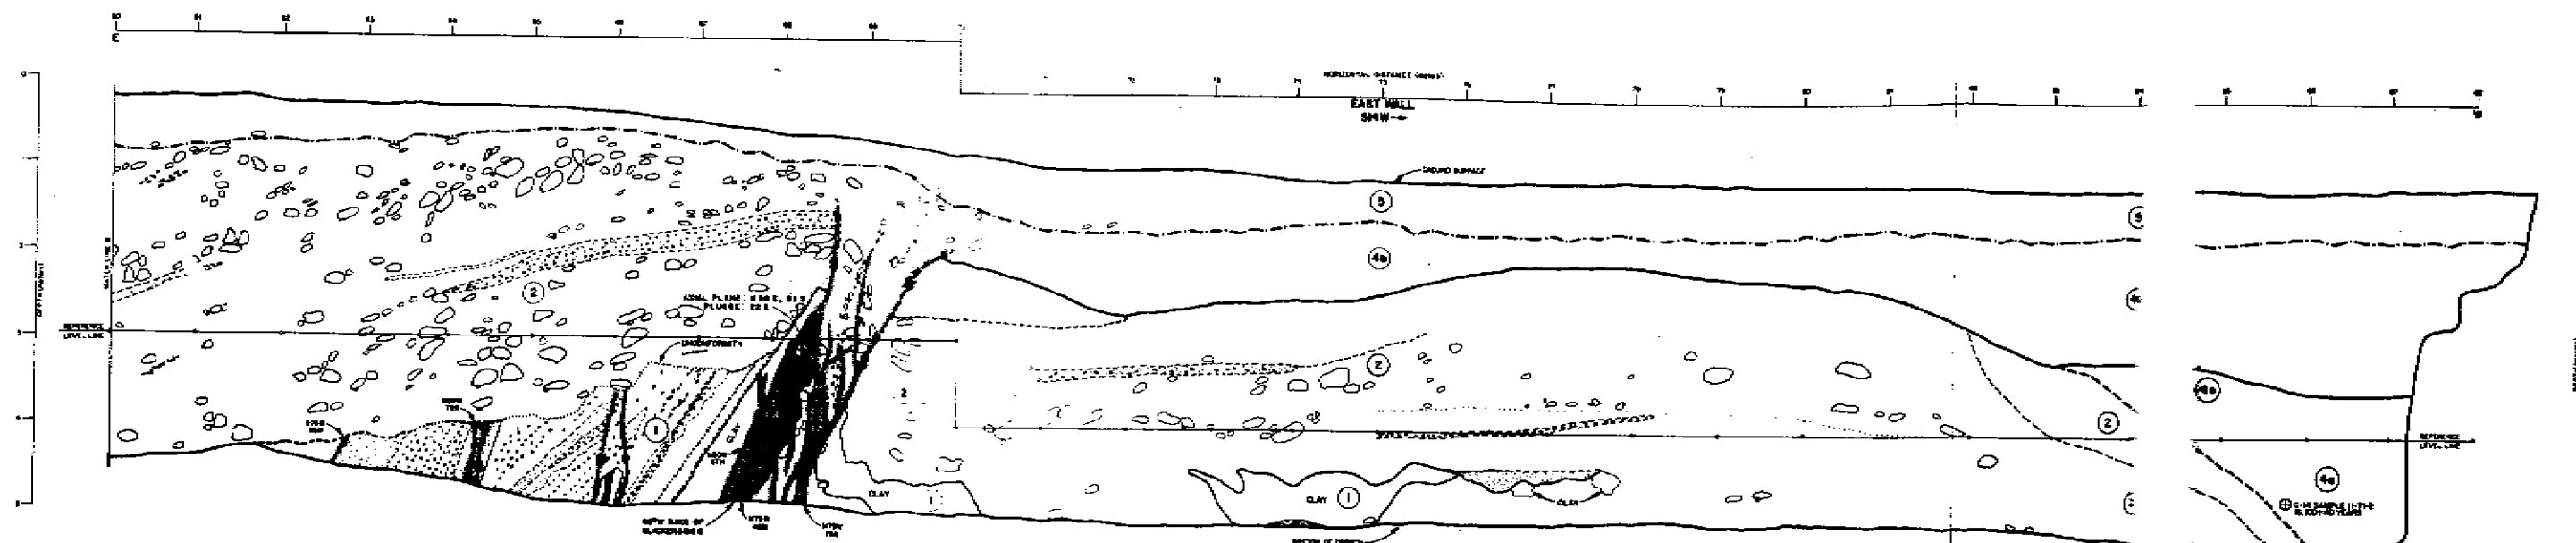
FEB-130. Figure 3 (2 pages). From Coppersmith (1980).

Coppersmith (1980, p. B-14 to B-21) reported finding two distinct zones of northeast-dipping reverse faults (having strikes of $N75^{\circ}W$ to $N85^{\circ}W$, and dips of 45° to 75° NE) which coincide with two one-meter high inflections of the ground surface along the linear ridge. Stevens (p.c.) feels that these two inflections are probably the result of cattle traversing the site and compacting and displacing the soil. Coppersmith reported that the fault surfaces were best preserved in the Carlotta Formation, where slickensides with rakes of $50^{\circ}W$ to $75^{\circ}W$ were observed. Because the materials exposed within the fault zone consist of coarse gravels, Coppersmith concluded that the majority of the deformation took place as intergranular rotation.

Coppersmith noted that the geologic units along the fault appear "progressively warped with age," suggesting repeated fault movement has occurred during the Quaternary. Based on the stratigraphic relationships he concluded there was evidence of at least three episodes of displacement exposed in the trenches. He reported that lake deposits younger than $16,000 \pm 110$ years before present (ybp) are in fault contact with older Yager Creek alluvium (Figure 3, station 70). He also cited additional young faults some of which displace the contact between young lake deposits and older alluvium, but he lacked evidence that would conclusively demonstrate, beyond any question, that Holocene fault movement had occurred. He did conclude that warping of the lake sediments (dated 8715 ± 195 ybp) (and, possibly, displacement) has occurred.

GOOSE LAKE EXPLORATION LOCALITY
TRENCH LOG 11-T1

Regarding displacement, Coppersmith reports that a scarp-derived colluvial wedge (at station 67, Figure 3) has a maximum thickness of about one meter suggesting that the single event displacement along that particular fault was about one meter. Using a different line of reasoning, he refers to the existence of the two most recent faults ^{*exposed in the trench*} and assumes each was produced by a separate event (noting this may not be the case). Using the net displacement (4.0 to 8.5 meters), he concludes that the displacement per event is less than or equal to 3 to 4 meters.

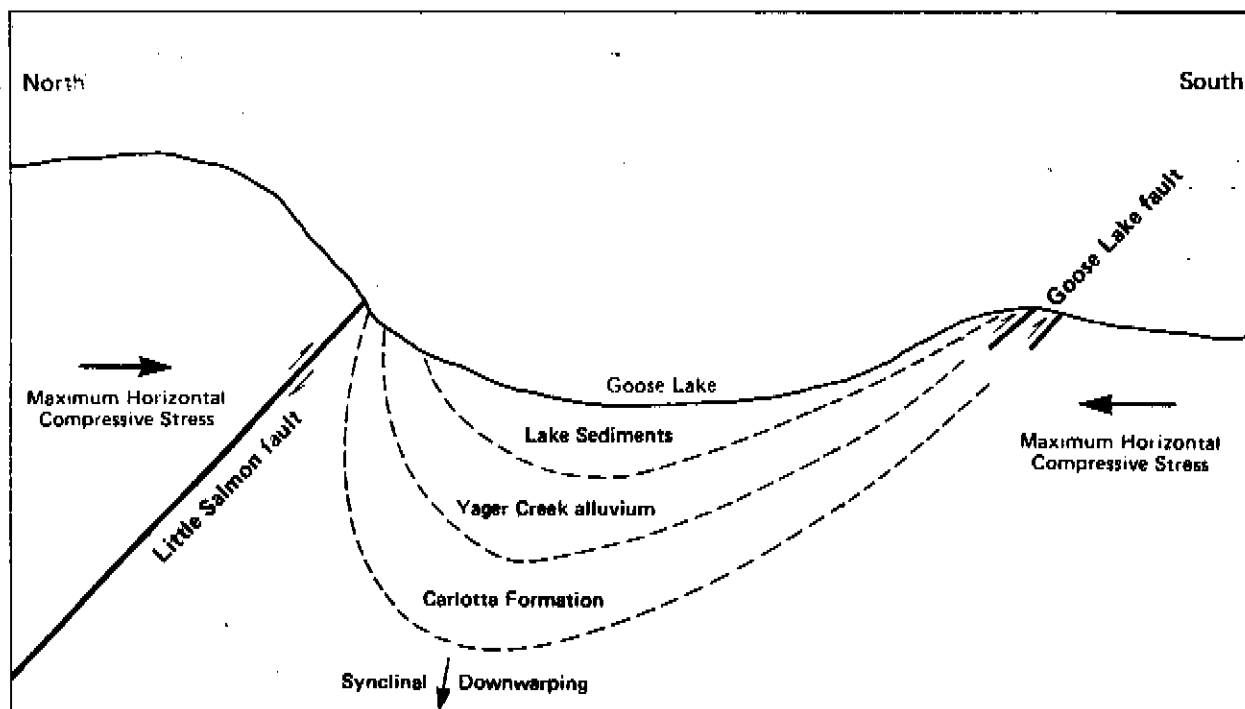
FER-130. Figure 4. From Coppersmith (1980).

Coppersmith (p. B-21 to B-23) noted that the apparent sense of vertical movement along the Goose Lake fault is opposite that of the Little Salmon fault. In the model he presented to explain this apparent discrepancy, the regional crustal shortening occurs as both folding and reverse fault movement. He described the area between the Goose Lake and the Little Salmon faults as a syncline, and postulated that the rate of downwarping in the block exceeds the rate of vertical slip on the Goose Lake fault (see Figure 4). Stevens (p.c.) noted that Coppersmith's is not very plausible, and that it did not really account for the observed evidence supporting the strike-slip component of movement.

Schematic north-south cross section showing Little Salmon fault and Goose Lake fault. Rate of synclinal downwarping is assumed to exceed rate of slip on Goose Lake fault.

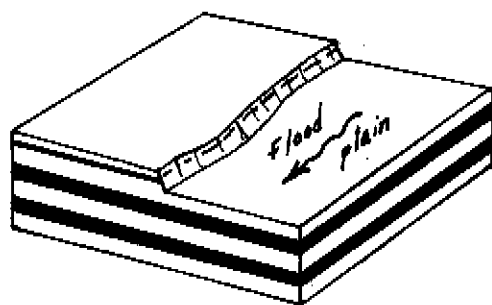
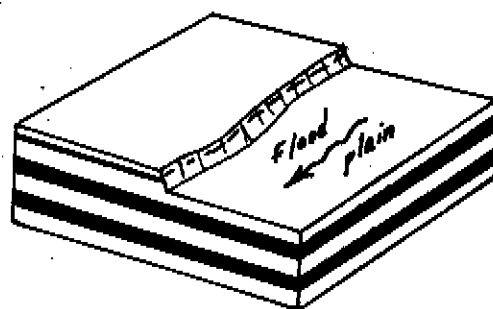
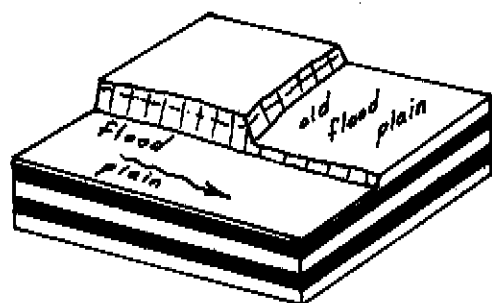
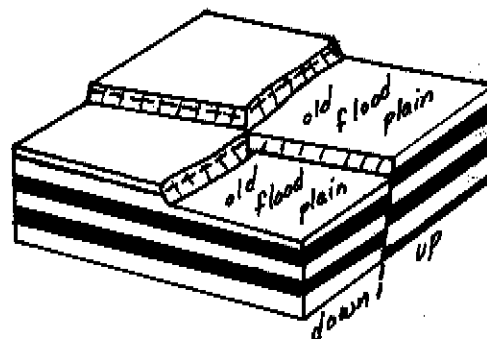
Figure 6. Hypothetical topography resulting from erosion (a₁ and b₁) and erosion with subsequent fault movement (a₂ and b₂).

fault and fault "A" can be argued on the basis of geomorphic evidence alone (schematically shown in Figure 6). If, after an erosional escarpment (such as a streambank) is formed, fault movement occurs along a fault which trends at right angles to the escarpment, both the original erosional escarpment and the fault scarp can be preserved. But, if a second erosional escarpment is formed, the first escarpment is normally partially eroded (as in Figure 6b₂). Therefore, the several "crossing escarpments" present along each strongly support a tectonic origin for fault "A" and the Goose Lake fault. Also the lack of a scarp across the Fisher Road terrace (based on both air photo and field observations) strongly suggests that movement has not occurred along either the Goose Lake fault or fault "A" since the terrace surface was formed. (No evidence that the terrace surface has been highly modified was found.)
